# Flow-Liner® “Goes to Court”

## Federal Court House Building Pipe Lining Project

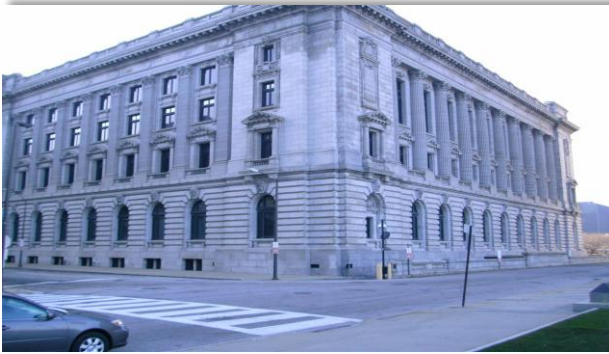
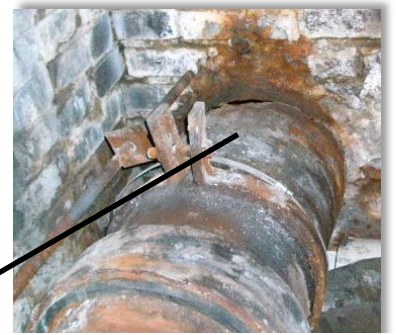
Cracked and deteriorated pipe exiting through wall

A Flow-Liner® Certified Installer mobilized a crew the night before Thanksgiving Day to the site. The crew worked through the night and installed the Flow-Liner® Sectional Cured-In-Place-Pipe Lining System.

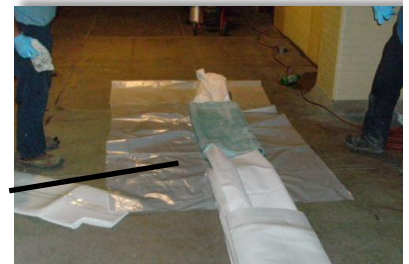
Pipe liner being prepared

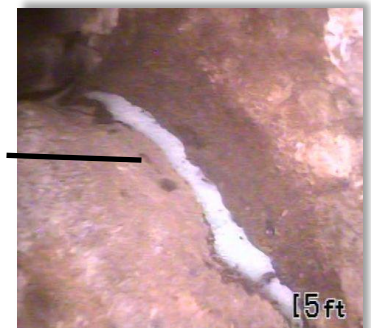
Cracked portion of pipe sealed by the sectional CIPP liner
