Flow-Liner® Performs “Emergency Non-Invasive Pipe Surgery”

The Hospital Maintenance Dept. had a 6 inch cast iron drain pipe in need of repair.

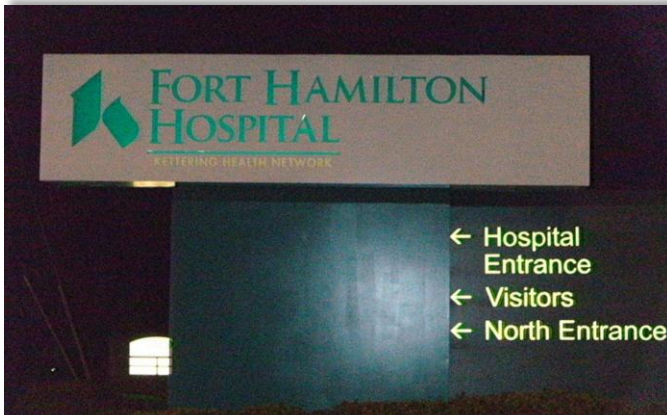
6 inch cast iron pipe located in ceiling and difficult to access

A Flow-Liner® Certified Installer will line the cast iron pipe utilizing the Flow-Liner® Sectional Cured-In-Place-Pipe Lining System. The non-invasive operation will be performed at night so the hospitals day-to-day activities will not be disturbed.

The pipe was lined and able to be used by the next morning. The other utilities surrounding the pipe in the ceiling were not disturbed or damaged. The pipe was saved with a 50+ year extended life span. The Maintenance Dept. was very pleased with the performance and result.

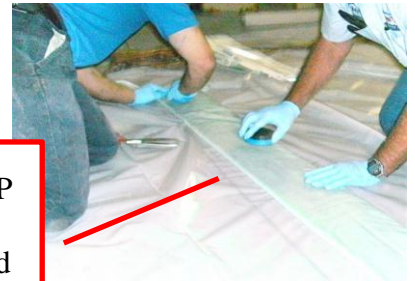
Sectional CIPP Flow-Liner® being prepared

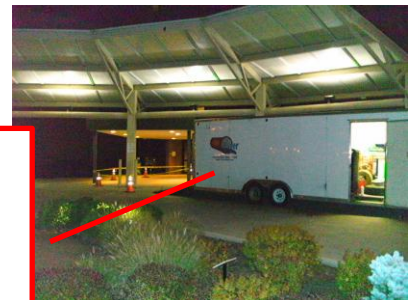
Flow-Liner® Installer trailer during night time operation

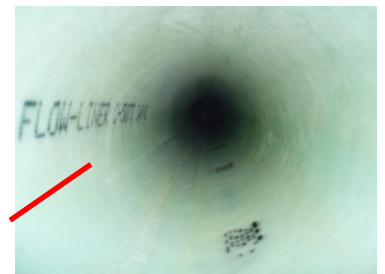
Flow-Liner® Installed inside of 6 inch cast iron pipe
